## STORRS POND DAM

NH 00050

### PHASE I INSPECTION REPORT NATIONAL DAM INSPECTION PROGRAM

NOVEMBER 1979

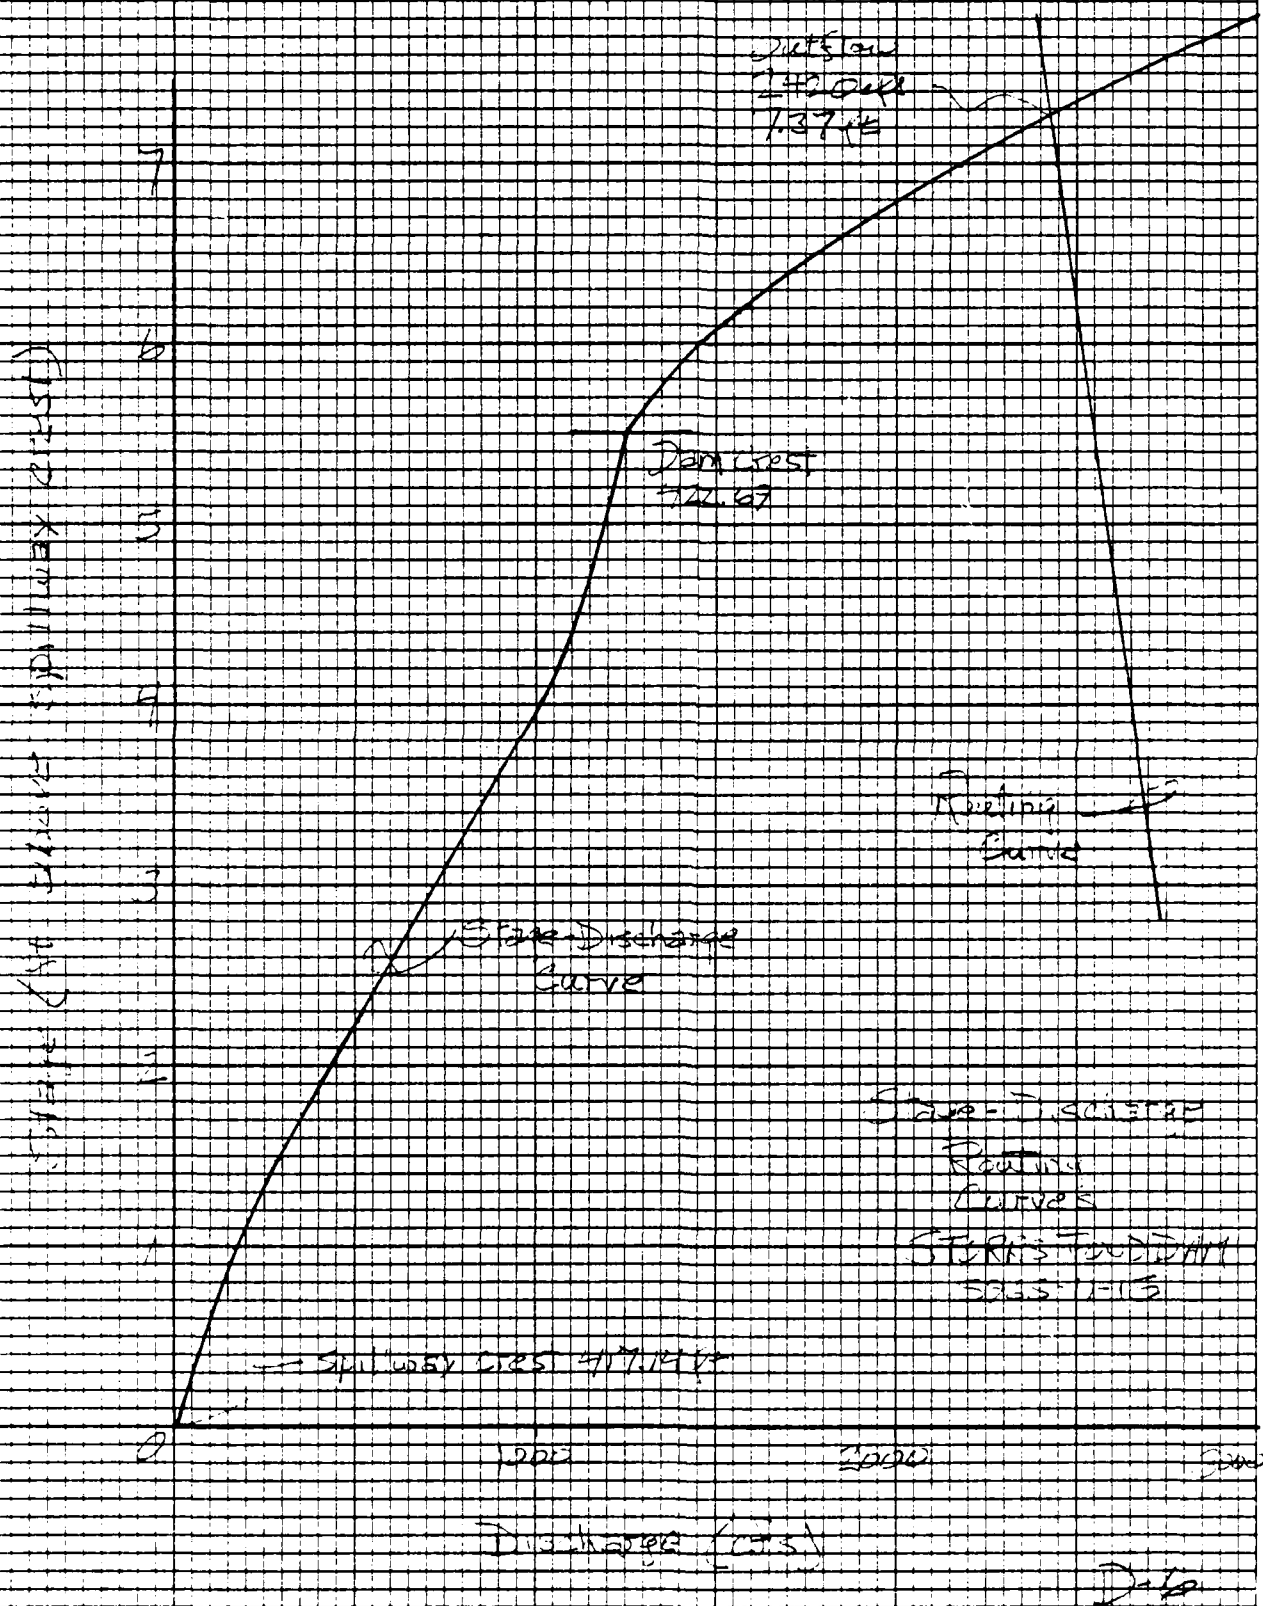
FIGURE 1

See figure 1 for Outflow 2420 cfs  
 Stage 7.37 ft  
 elev 424.51  
 Overtopped by 1.82 ft

Spillway at top of dam 1247 cfs 51% of rated FF  
 Spillway at FF 1360 cfs

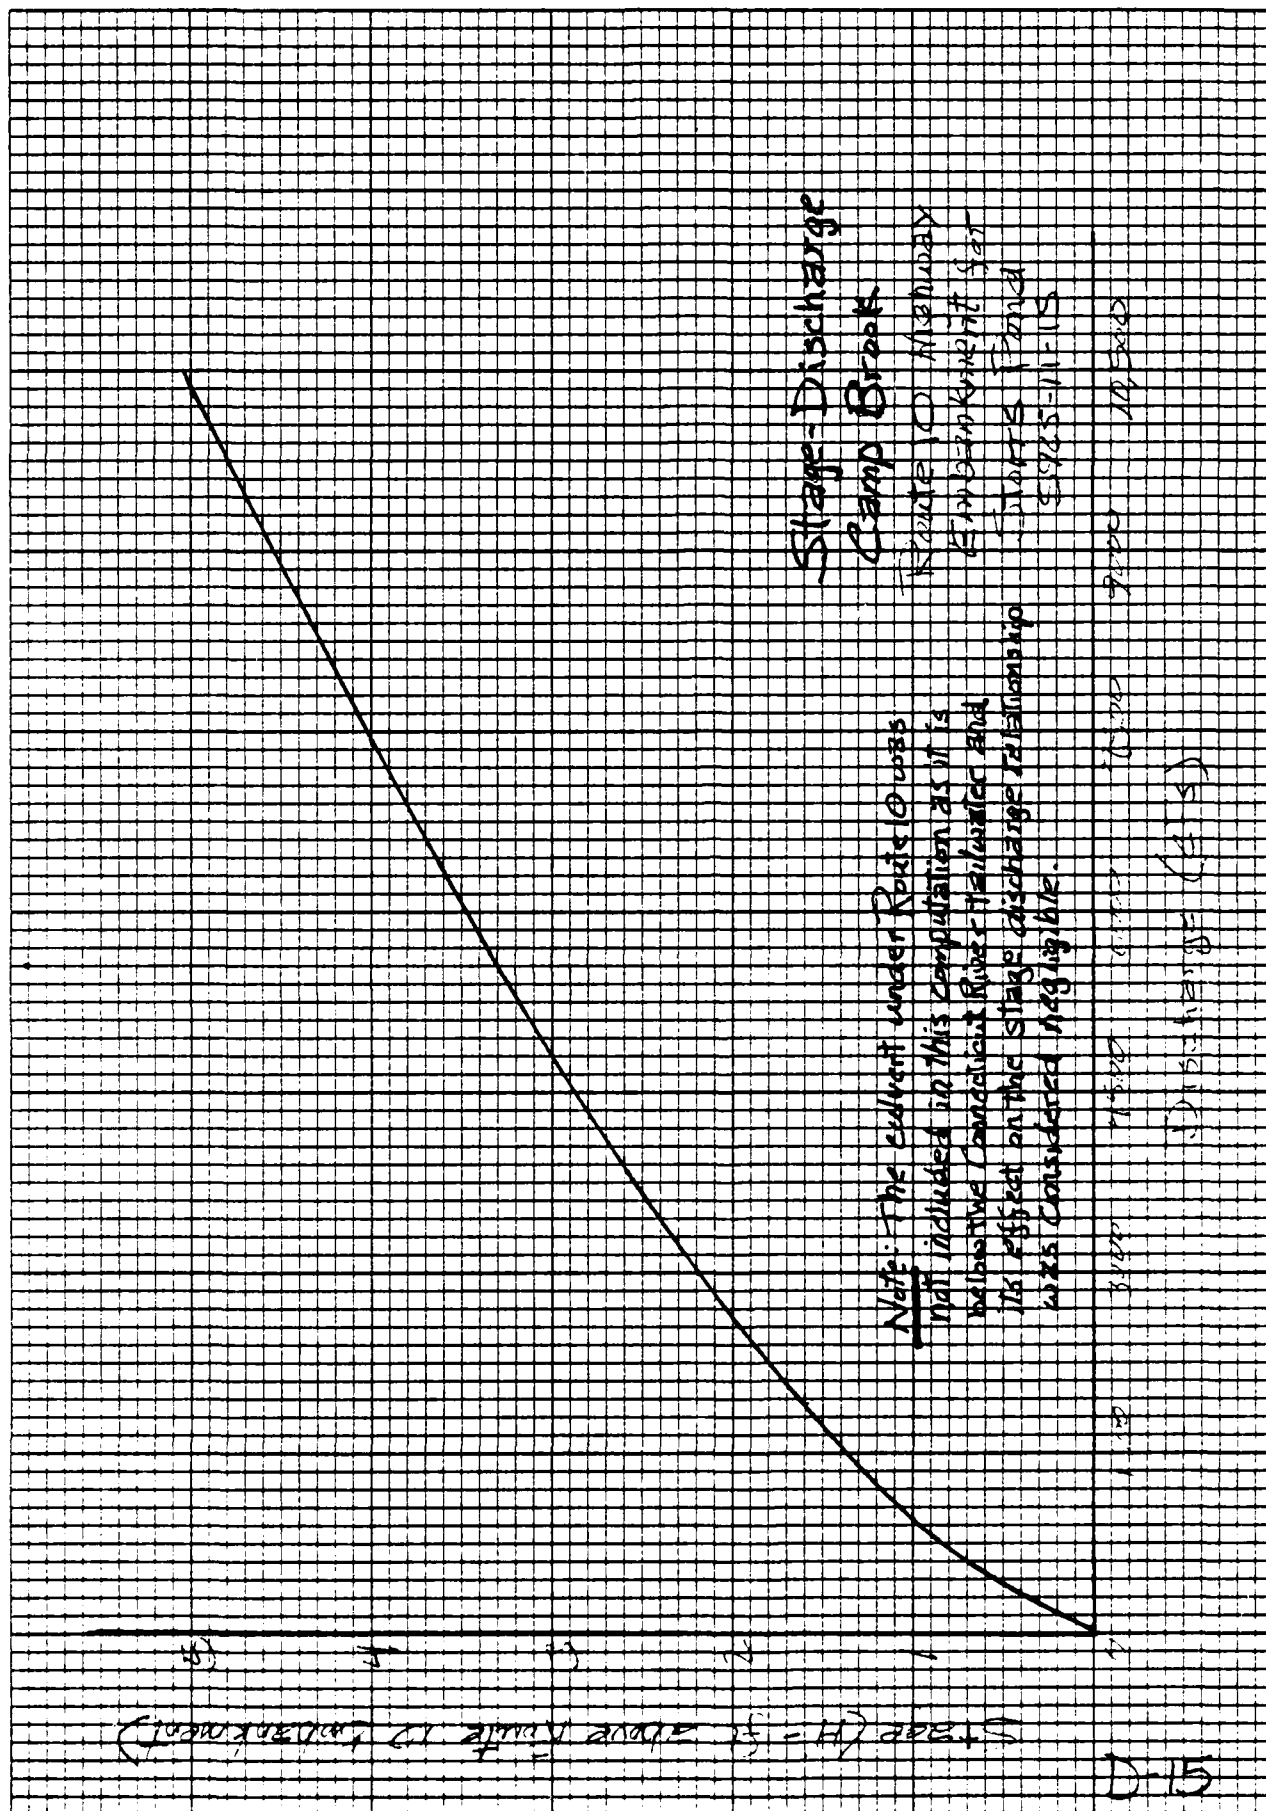
Figure 2

Stage  $H = 4.5 \text{ ft}$  depth of water above Route 10
